Appendix D

Airside and Landside Pavement Inventories

AKRON CANTON AIRPORT
PAVEMENT MANAGEMENT
AKRON CANTON AIRPORT
PAVEMENT MANAGEMENT
NETWORK

Landside Airfield Pavement Condition

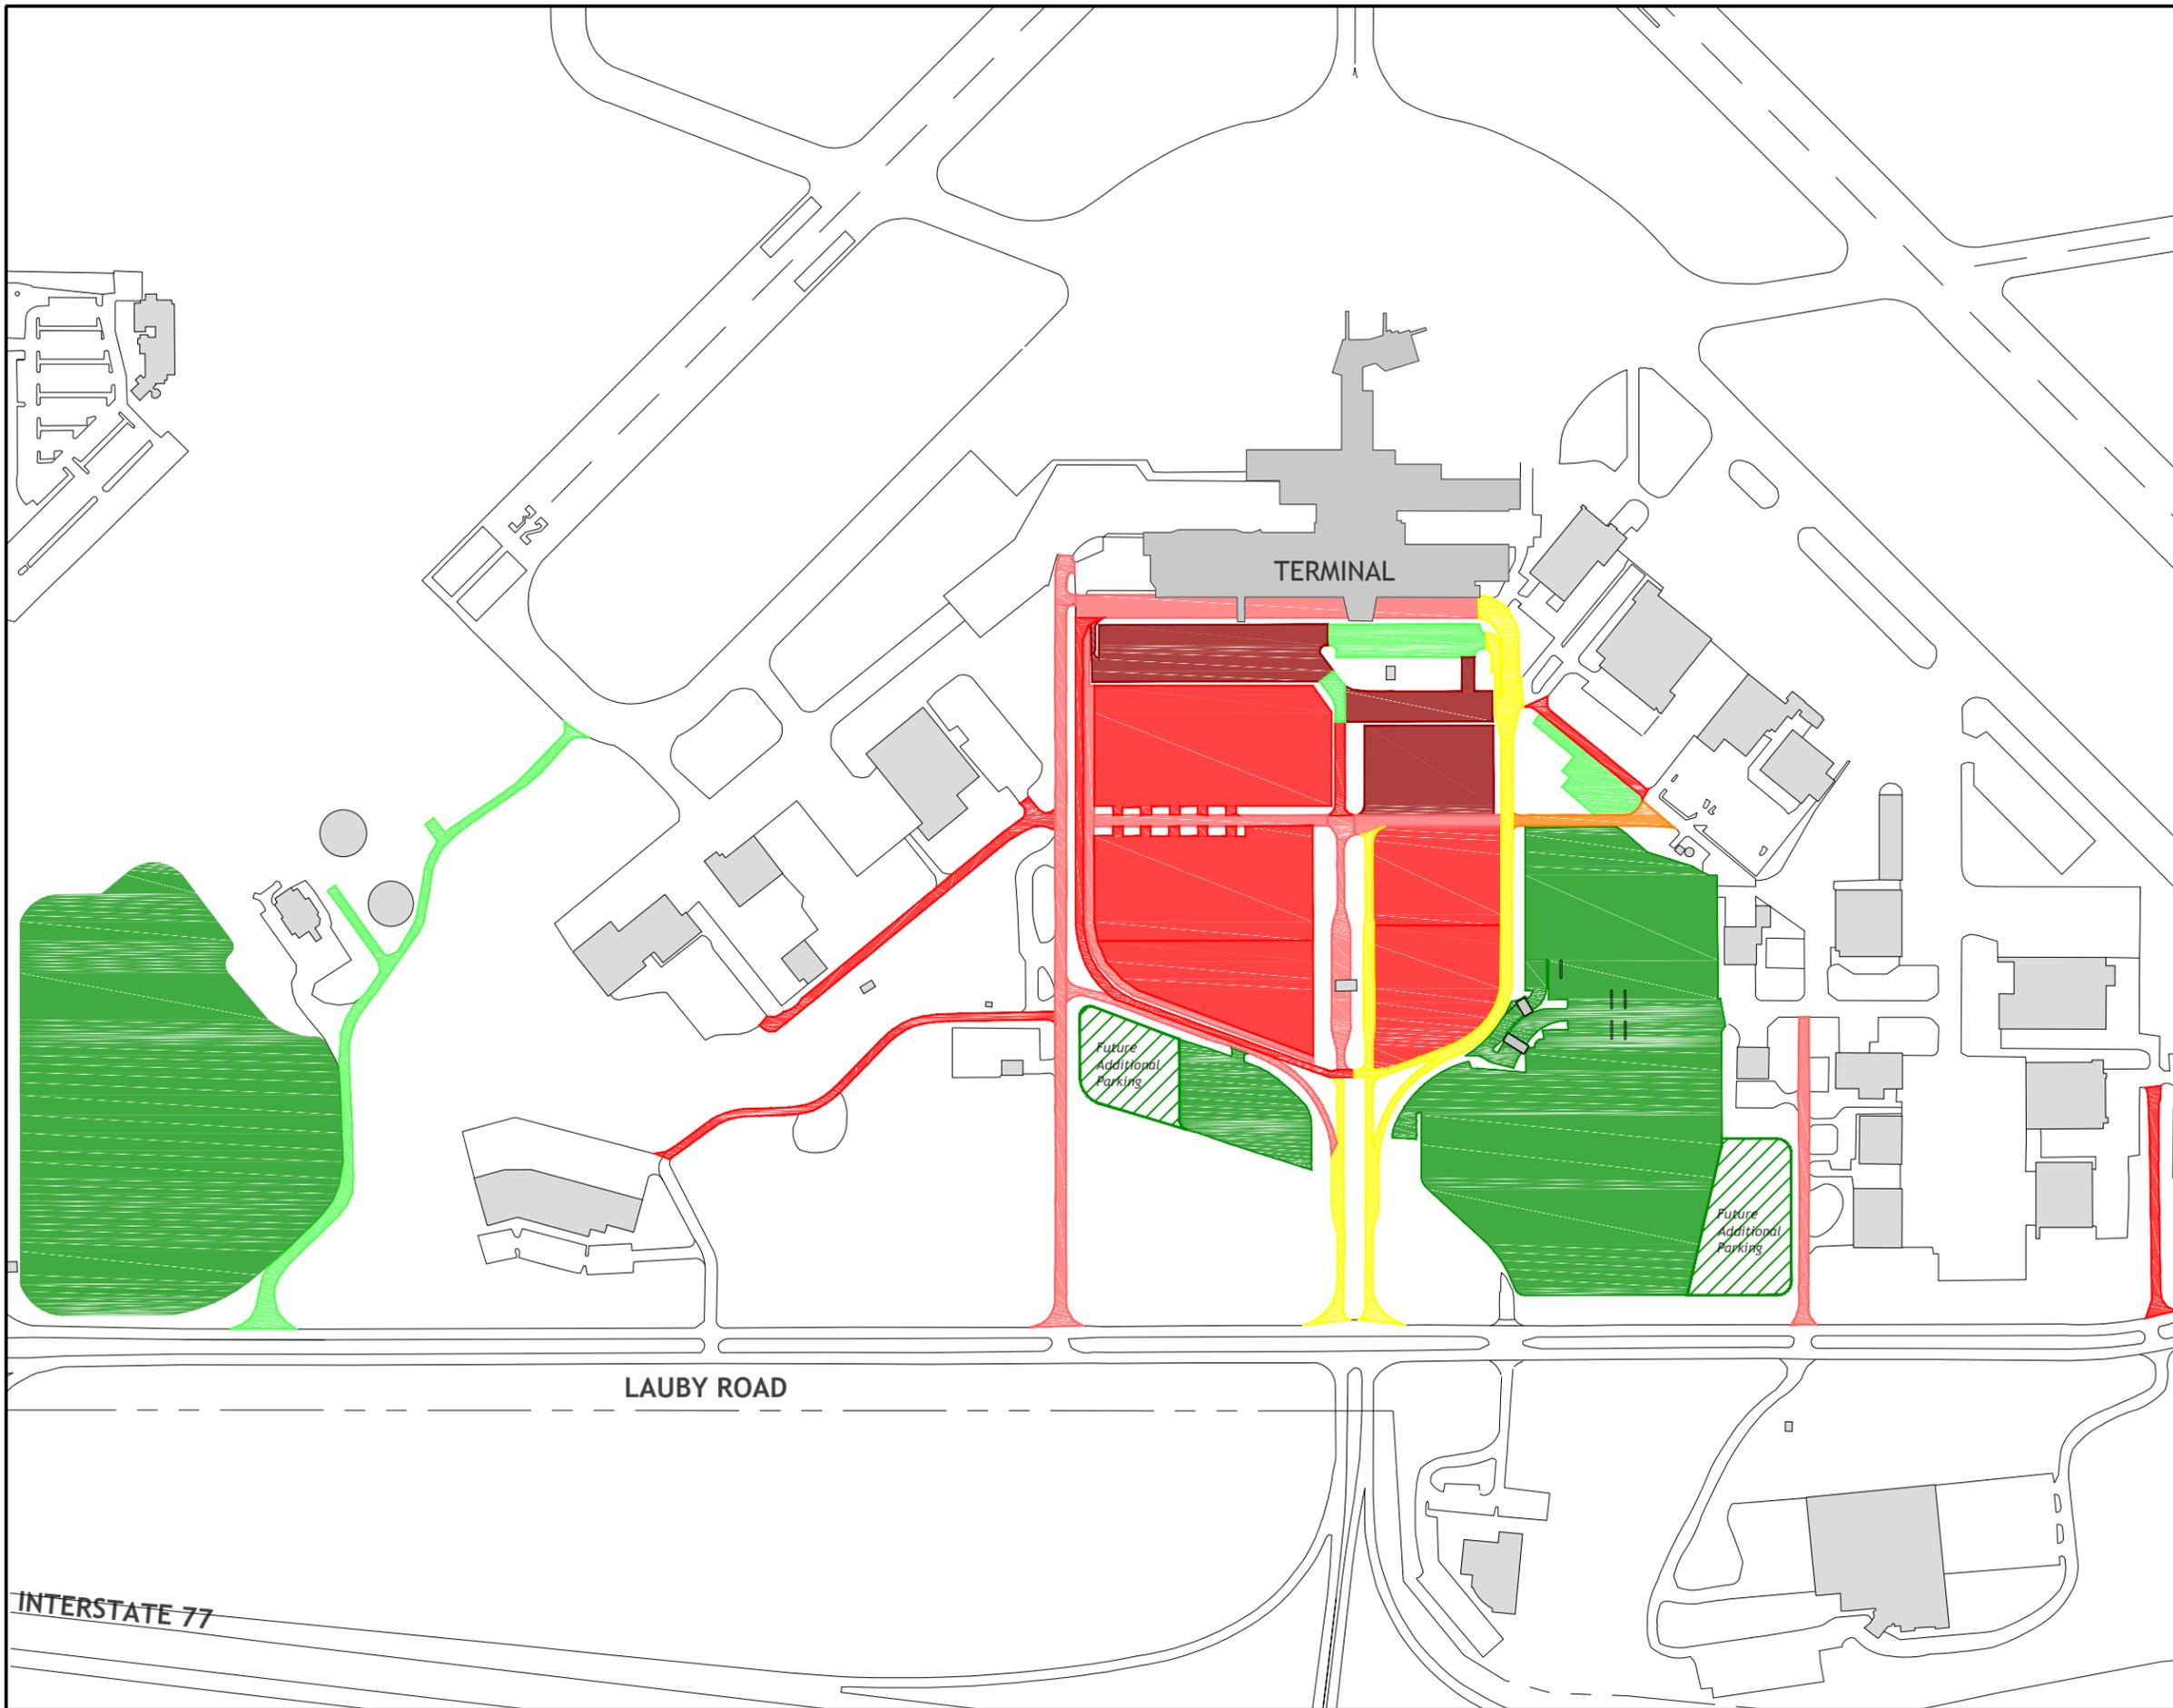
Figure 1
Landside Pavement Conditions

The landside pavement PCI values range from “Very Poor” (PCI = 19) to “Excellent” (PCI = 100). Most of the landside roadways are in Fair to Poor condition and most of the parking areas are in Poor to Very Poor condition. Table 1 and Figures 1 - 5 summarize the results of the PCI analysis. The exceptions are the Westbound Entrance Roads (Good condition), the Short-Term Parking Area (Very Good condition) and the newly constructed parking areas (Excellent condition).

1. Repair any significant defects (e.g., large potholes) that could result in damage to private vehicles;
2. Prioritize roadway sections based on the Master Plan and importance to the public using the airport; and
3. Select the highest priority sections for more detailed inspections to obtain information necessary to develop appropriate maintenance and repair projects and cost estimates.
